Large Area Mapping Using ISOCS™ and Geostatistics

Scenario generated from the ORNL scrap measurement campaign and Envisol's geostatistical analysis of data

Case Study

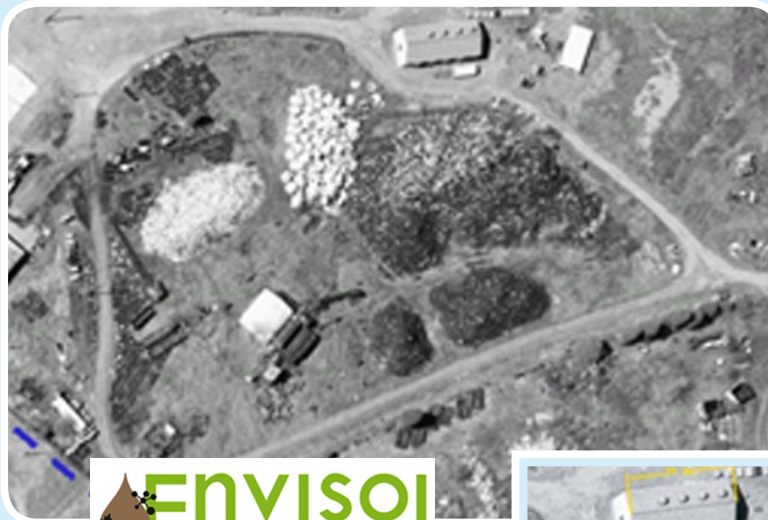
3 steel piles, 2 aluminum piles
27,000 tons total

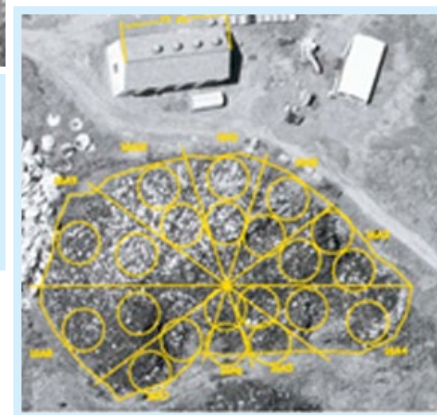
16A Pile:

- 21 Measurements
- 3 hours each
- Measurement footprint: 30'-diameter x 10"-20" deep

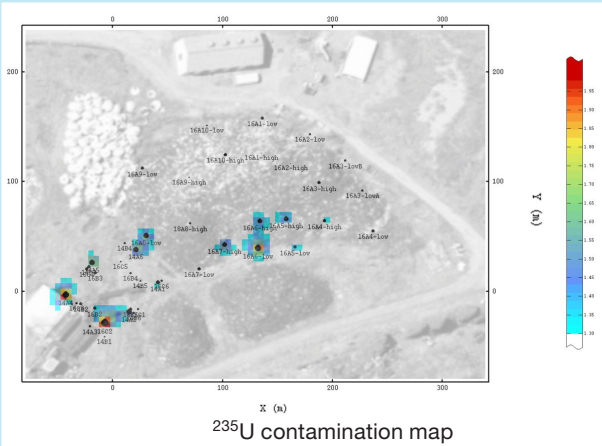
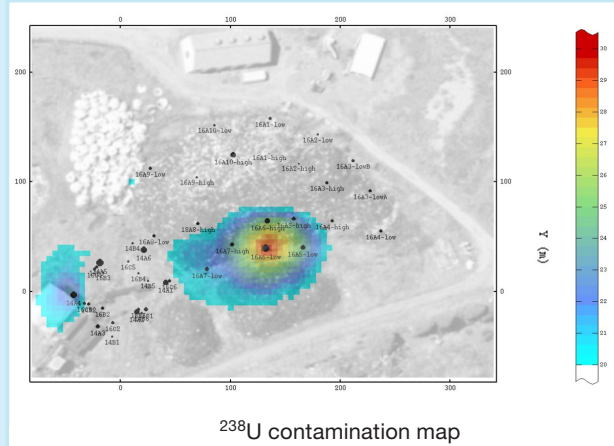
- Germanium detector with WIDE (150 degree) field-of-view collimator and ISOCS
- ENVISOL data analysis and interpretation using Geostatistics methodology
- 2D mapping of contaminated areas
